COLORADO CULTURAL RESOURCE SURVEY

Architectural Inventory Form

1. Resource number: **5SM.1775**
 2. Temporary resource number: **N/A**
 3. County: **San Miguel**
 4. City: **Telluride**
 5. Historic Building Name: **Cronkleton House, Ruggles House**
 6. Current Building Name: **Freidus House**
 7. Building Address: **310 N. Spruce Street**
 8. Owner Name and Address: **Bernice Ann Freidus
P. O. Box 3131
Telluride, CO 814353131**

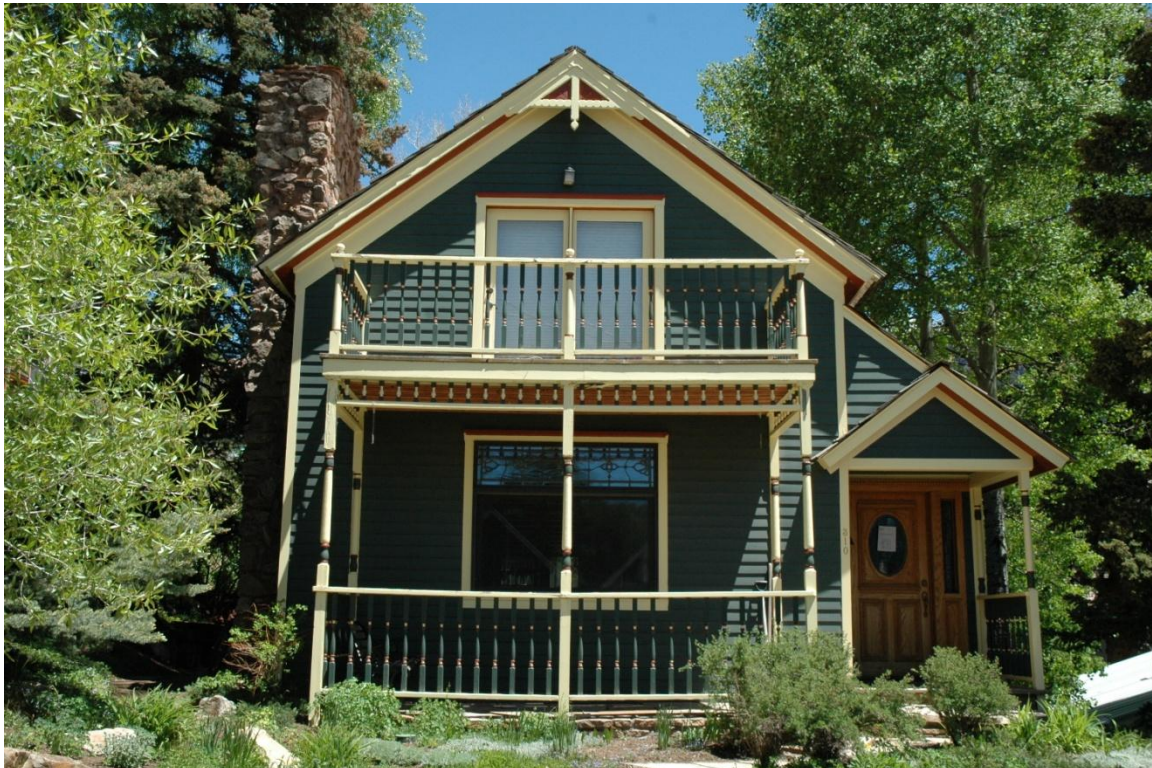
21. General architectural description:
This residence is composed of an original (1891) 1½-story front gabled dwelling, with a large rear addition to the east elevation. The original portion measures 18½' N-S (across) by 26½' E-W (deep) with a 6' by 8' single-story shed-roofed extension to the west end of the south elevation. The house's exterior walls are clad with painted forest green horizontal wood siding, with painted cream yellow 1" by 4" corner boards. The roof is covered with wood shingles, and the eaves are boxed with painted cream yellow wood trim. A large stone fireplace chimney is located at the west end of the north elevation. A gable ornament appears in the facade's upper gable end on the west elevation. A non-historic stained brown wood-paneled door, with an oval-shaped upper sash light and with narrow sidelights, enters the south end of the facade from the open front porch. The porch measures six feet square and features a wood plank floor, an open wood railing with turned balusters, turned columns, and a gabled roof. South of the entry porch, much of the facade is covered by a non-historic elevated upper half story porch above a flagstone patio. This porch measures 15' N-S by 5' E-W, and features turned columns, and two open wood railings with turned balusters – one at ground level enclosing the flagstone patio, and the other enclosing the upper half story porch. A non-historic glass-in-wood-frame atrium door opens from the upper half story onto the elevated porch. A non-historic 1x1 horizontal sliding window, with a leaded glass transom light, penetrates the facade wall, overlooking the flagstone patio. A stained brown wood-paneled door, with one upper sash light, enters the north elevation of the addition from a shed-roofed porch. A painted cream yellow wood-paneled door, with one upper sash light, enters the addition's east elevation from a wood plank porch covered by a flat roof. This porch has painted cream yellow turned columns, a spindle frieze, and its roof serves as another upper half story porch accessed by a glass-in-wood-frame door.

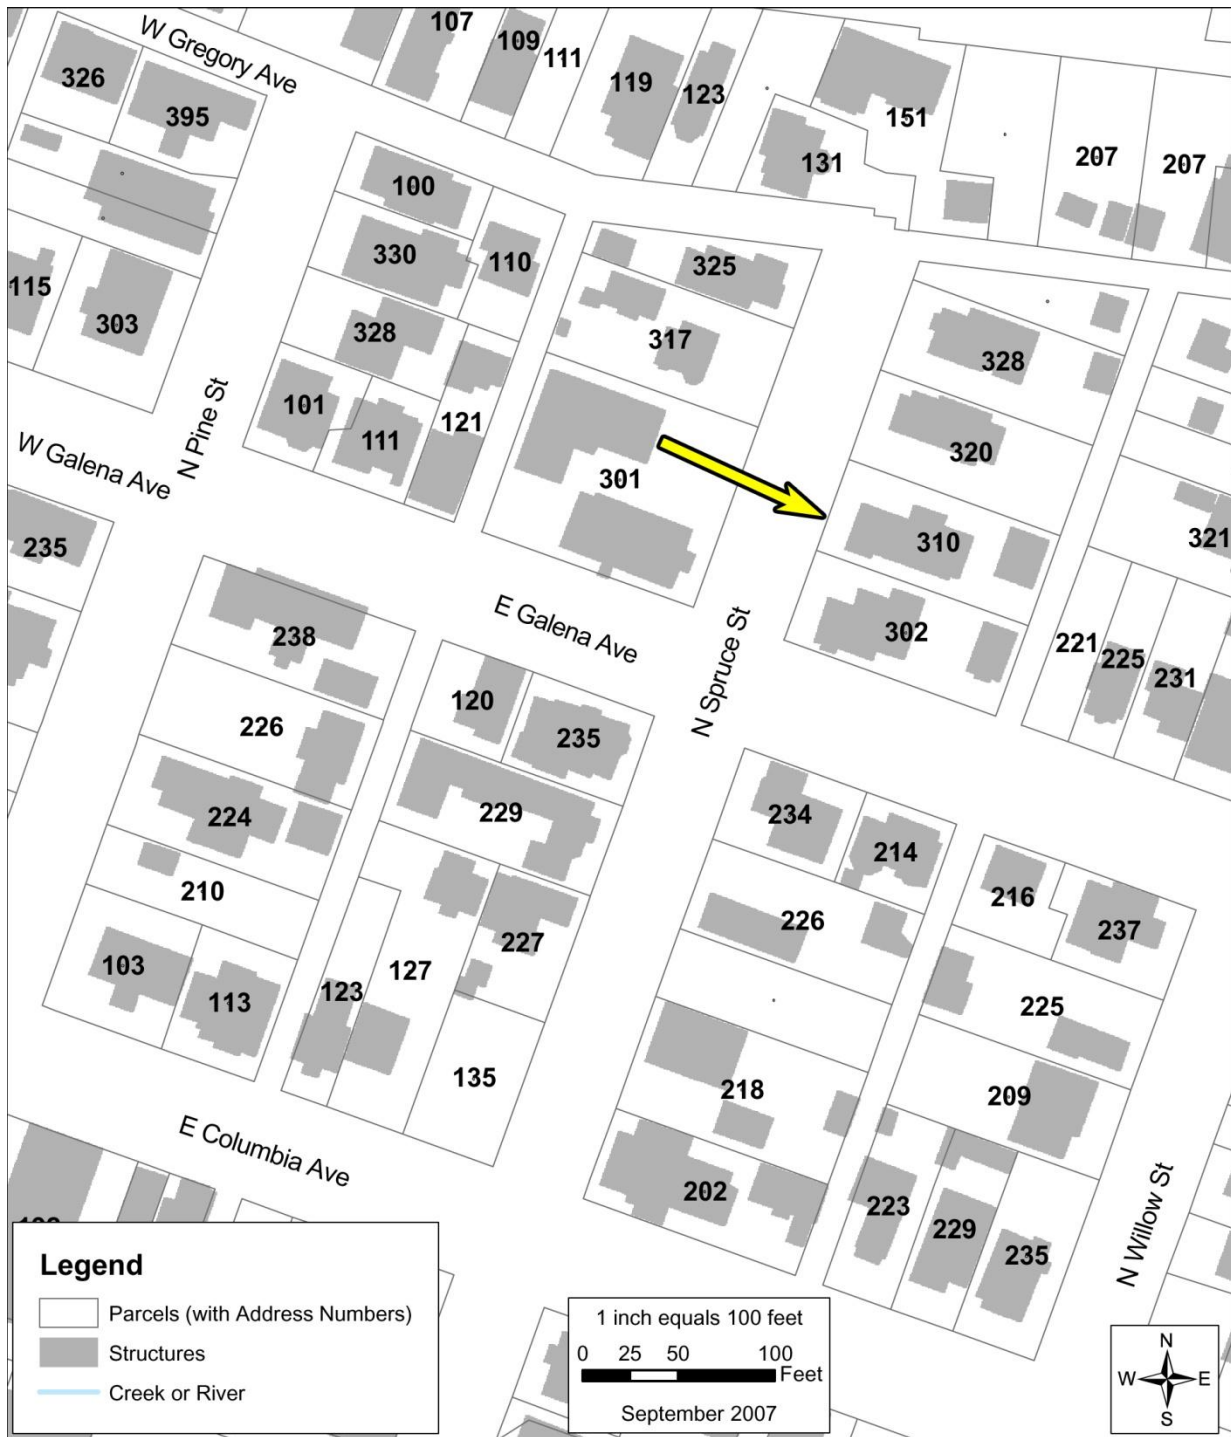
Sketch Map

This is the second house north of Galena Avenue on the east side of N. Spruce Street. A planted grass front yard and narrow side yards flank the residence. A spruce tree is in the front yard northwest of the house,
